PAPKE'S LANDING

2. DETAILED ASSESSMENT

PREPARED FOR: PETERSBURG BOROUGH

DATE: 11/17/15

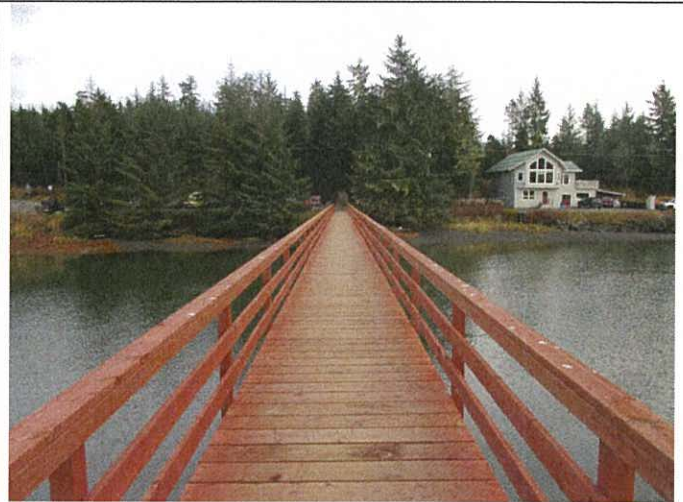
The timber approach is in good condition (Photo 2). It was reportedly re-decked and new handrails were installed in 2013. The handrail and decking appear to be constructed using off the shelf dimensional treated lumber. Treatments used in this type of lumber are typically ACQ or similar, which do not have the same long term design life as those typically specified in marine applications. It can be expected that the new timber decking will be good for 10 years or so.

2. Papke's Approach, Topside

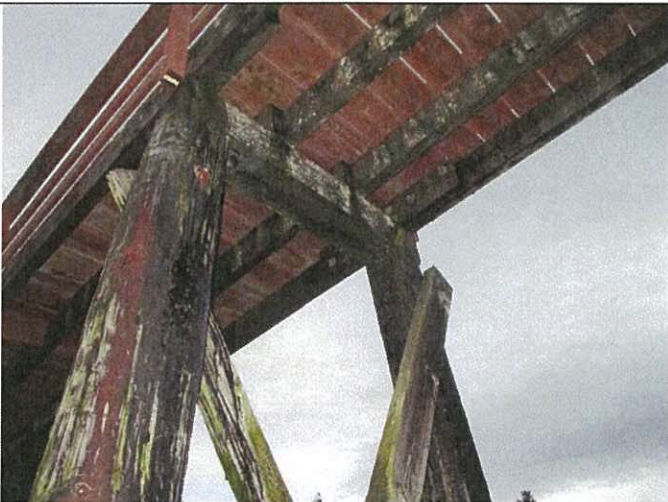
The piling, cap, and stringers (Photo 3) are heavily creosoted, and appear to be in good condition. It appears these timber components have approximately 20 years of useful life remaining before requiring significant repairs.

3. Papke's Approach, Typical Framing

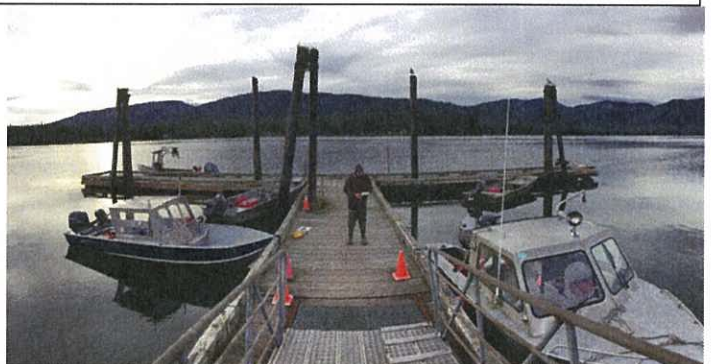
The timber float (Photo 4) is in poor condition, and it appears to be at or near its useful life. The decking is mostly in fair condition with many boards being highly weathered. About 10 % of the boards are spongy and deflect significantly when walked on (Photo 8). The bullrail has locations of rot and decay, frequent structural cracks and splits, and severe wear (Photo 6, 7). Several of the blocking are missing, and many bolts are loose or compromised (Photo 24). The bullrail is no longer sound, and may not be capable of adequately securing vessels. The rub strips are in poor condition, showing signs of heavy wear or missing completely. They are pulled up at the joints, and show cracks and abrasion damage.

4. Papke's Float

It is recommended that the float be replaced with a heavy duty concrete, timber, or steel pontoon unit. The location is exposed, and heavy currents likely bring ice and other debris in contact with this float. The float does not appear to be on the verge of breaking loose, but it has reached its useful life. Without repair or replacement, it is not expected to be safely useable beyond the next 5 years.

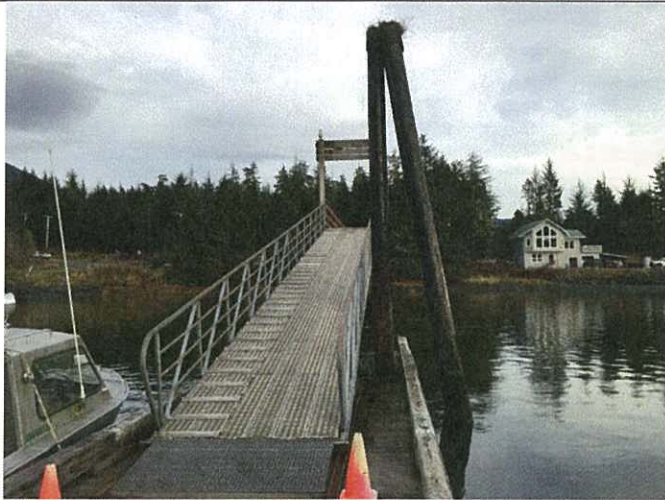
The steel gangway is in good condition (Photo 5), with only minor locations of coating loss and surface rust. The gangway is approximately 50' long, making it very steep at low tides, and not suitable for ADA access. It is recommended that the gangway be replaced as part of any significant rehabilitation to the approach or floating dock.

5. Papke's Gangway

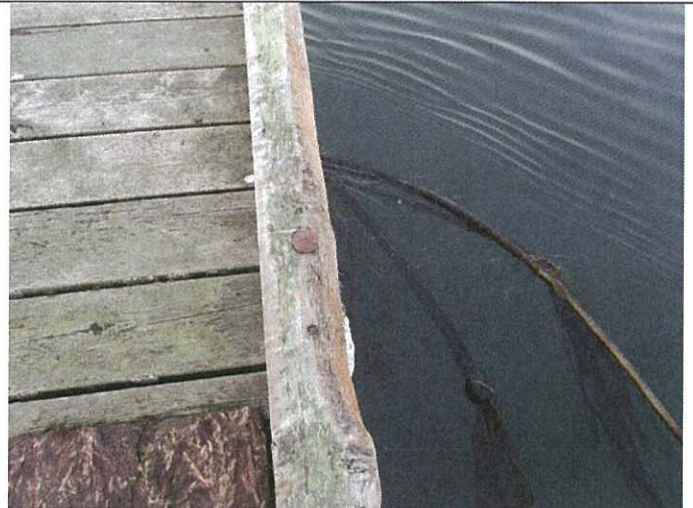
6. Papke's Worn Bullrail and Decking.

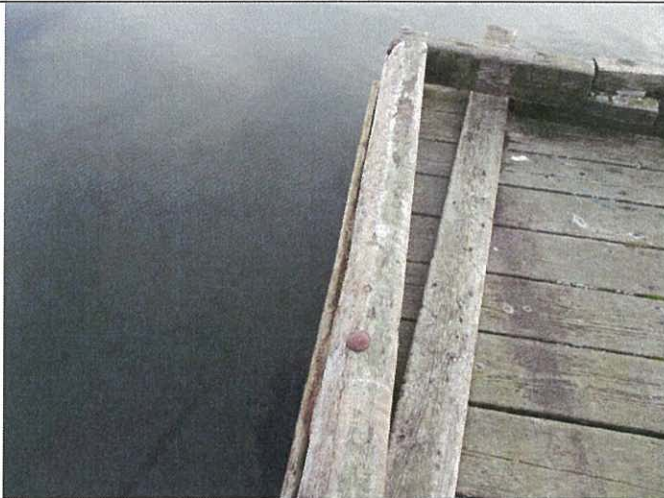
7. Papke's Worn, Broken Bullrail

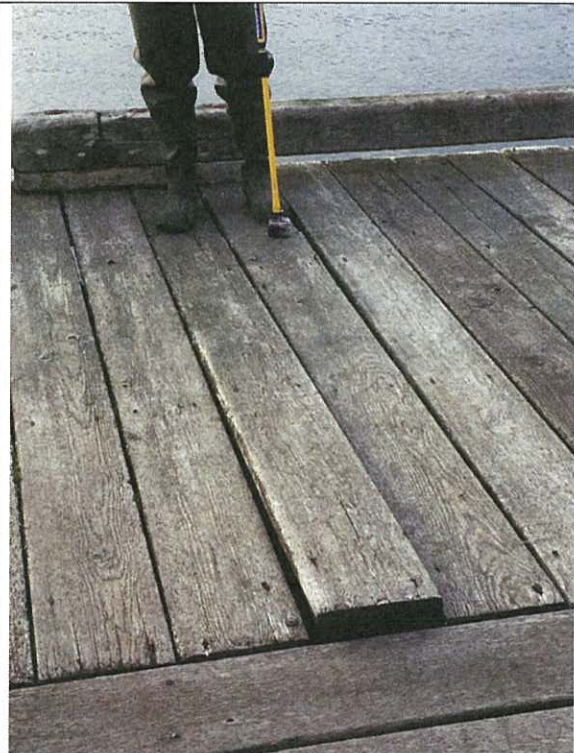
8. Papke's Float Decking

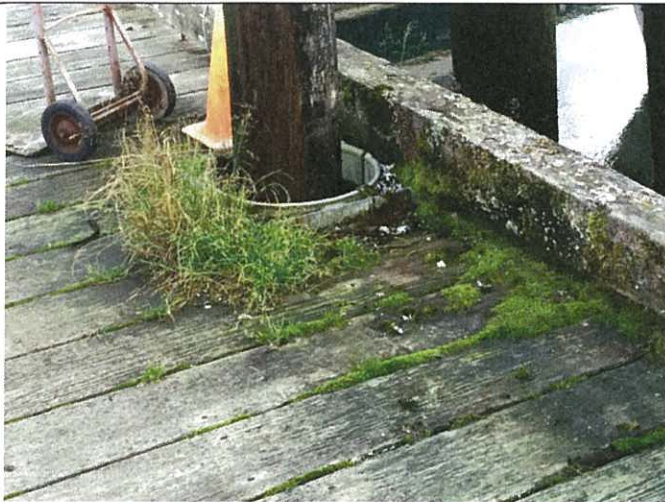
The existing timber piling appear to be in fair condition above the waterline, though rot and vegetation are apparent at the pile tops. It also appears the pile hoops have worn flat spots into the piling, reducing their sections (Photo 9). It is recommended that the piling be pulled and replaced at the same time as the float.

9. Wear on guide pile, note vegetation

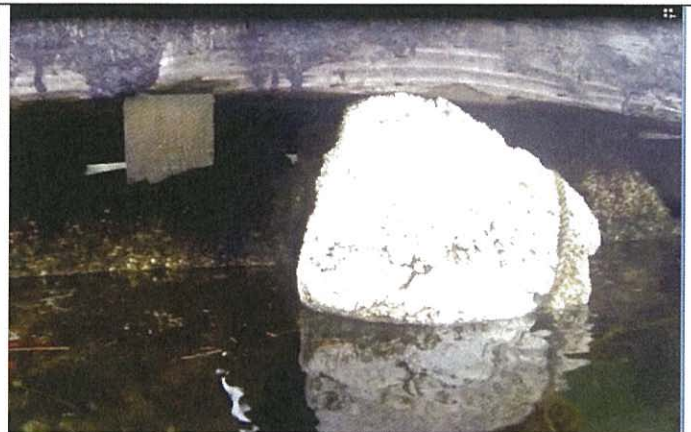
The flotation on the northeast corner of the float is heavily damaged (Photo 10). It appears outermost sill was damaged and the flotation is somewhat loose. More of this type of damage can be anticipated at more locations, as some of the other sills appear rotted and split.

10. Damage to Flotation and Sill

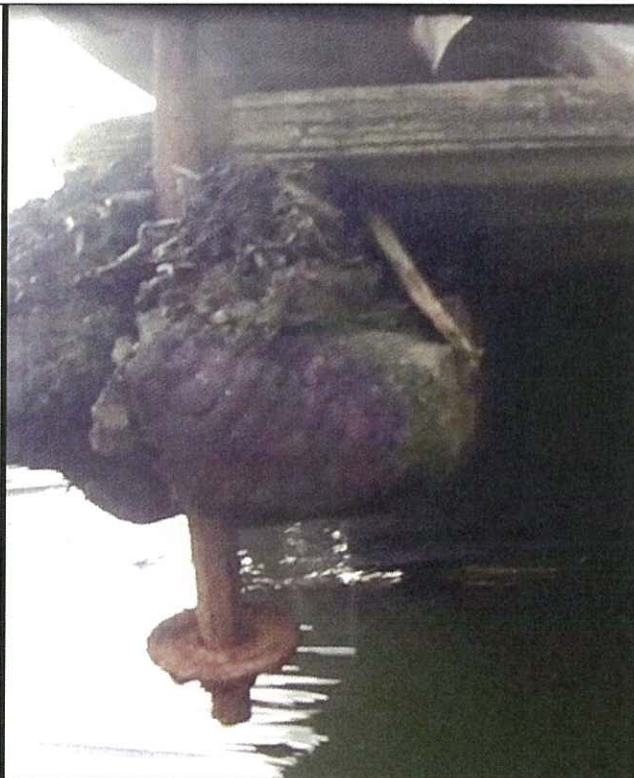
The fasteners in general appear to retain most of their section, however, the galvanizing is completely gone and corrosion is moderate with some showing heavy scaling (Photo 11, 12).

11. Damage sill and bolt, note corrosion.

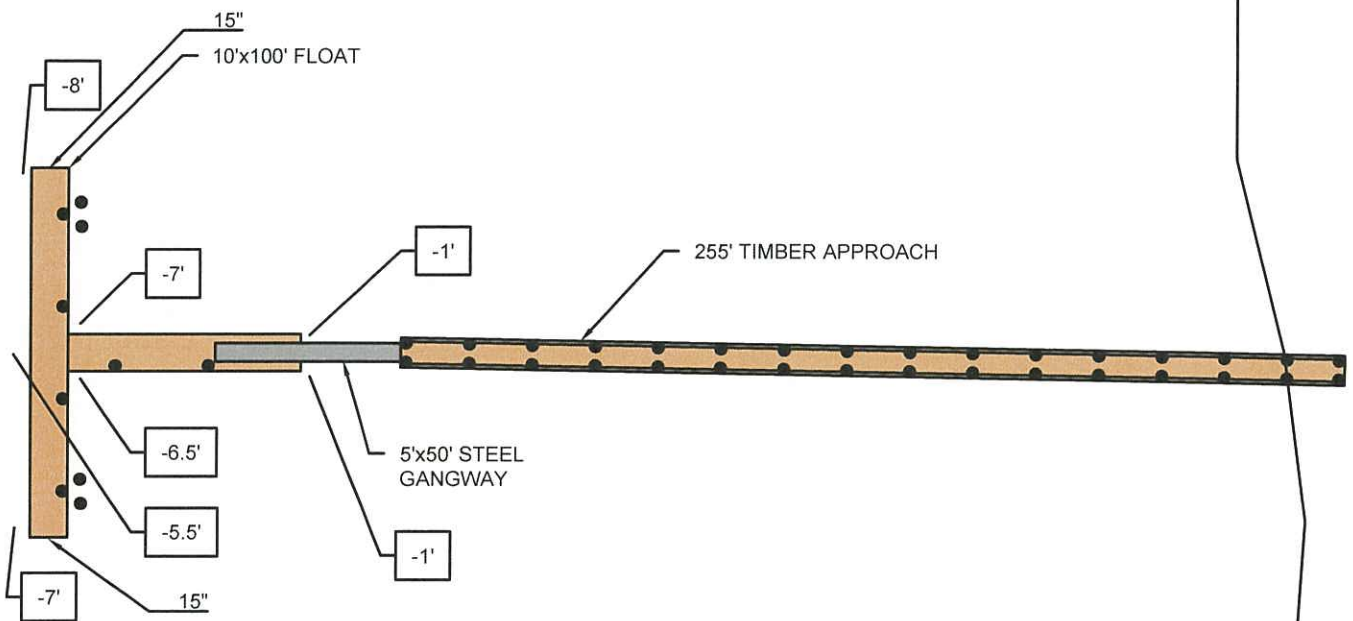
FIGURE 5

The float reportedly grounds at negative tides. Soundings show the shoreward end of the gangway float is at approximately -1' elevation (MLLW) and the middle of the outer face is at -5.5'. This shows that the gangway landing float grounds at low tide, and the outer face of the dock may not be useable by medium size vessels at extreme low tides. If the float is replaced, it should be moved offshore to deeper water to increase its functionality. If the float was moved out approximately 30', an ADA compliant 80' gangway could be installed, without substantial modification to the approach geometry.

Figure 5 indicates some soundings and freeboard values measured at the Papke Landing float.
