Roof Inspection: Petro Marine Building South Nordic

12-10-18

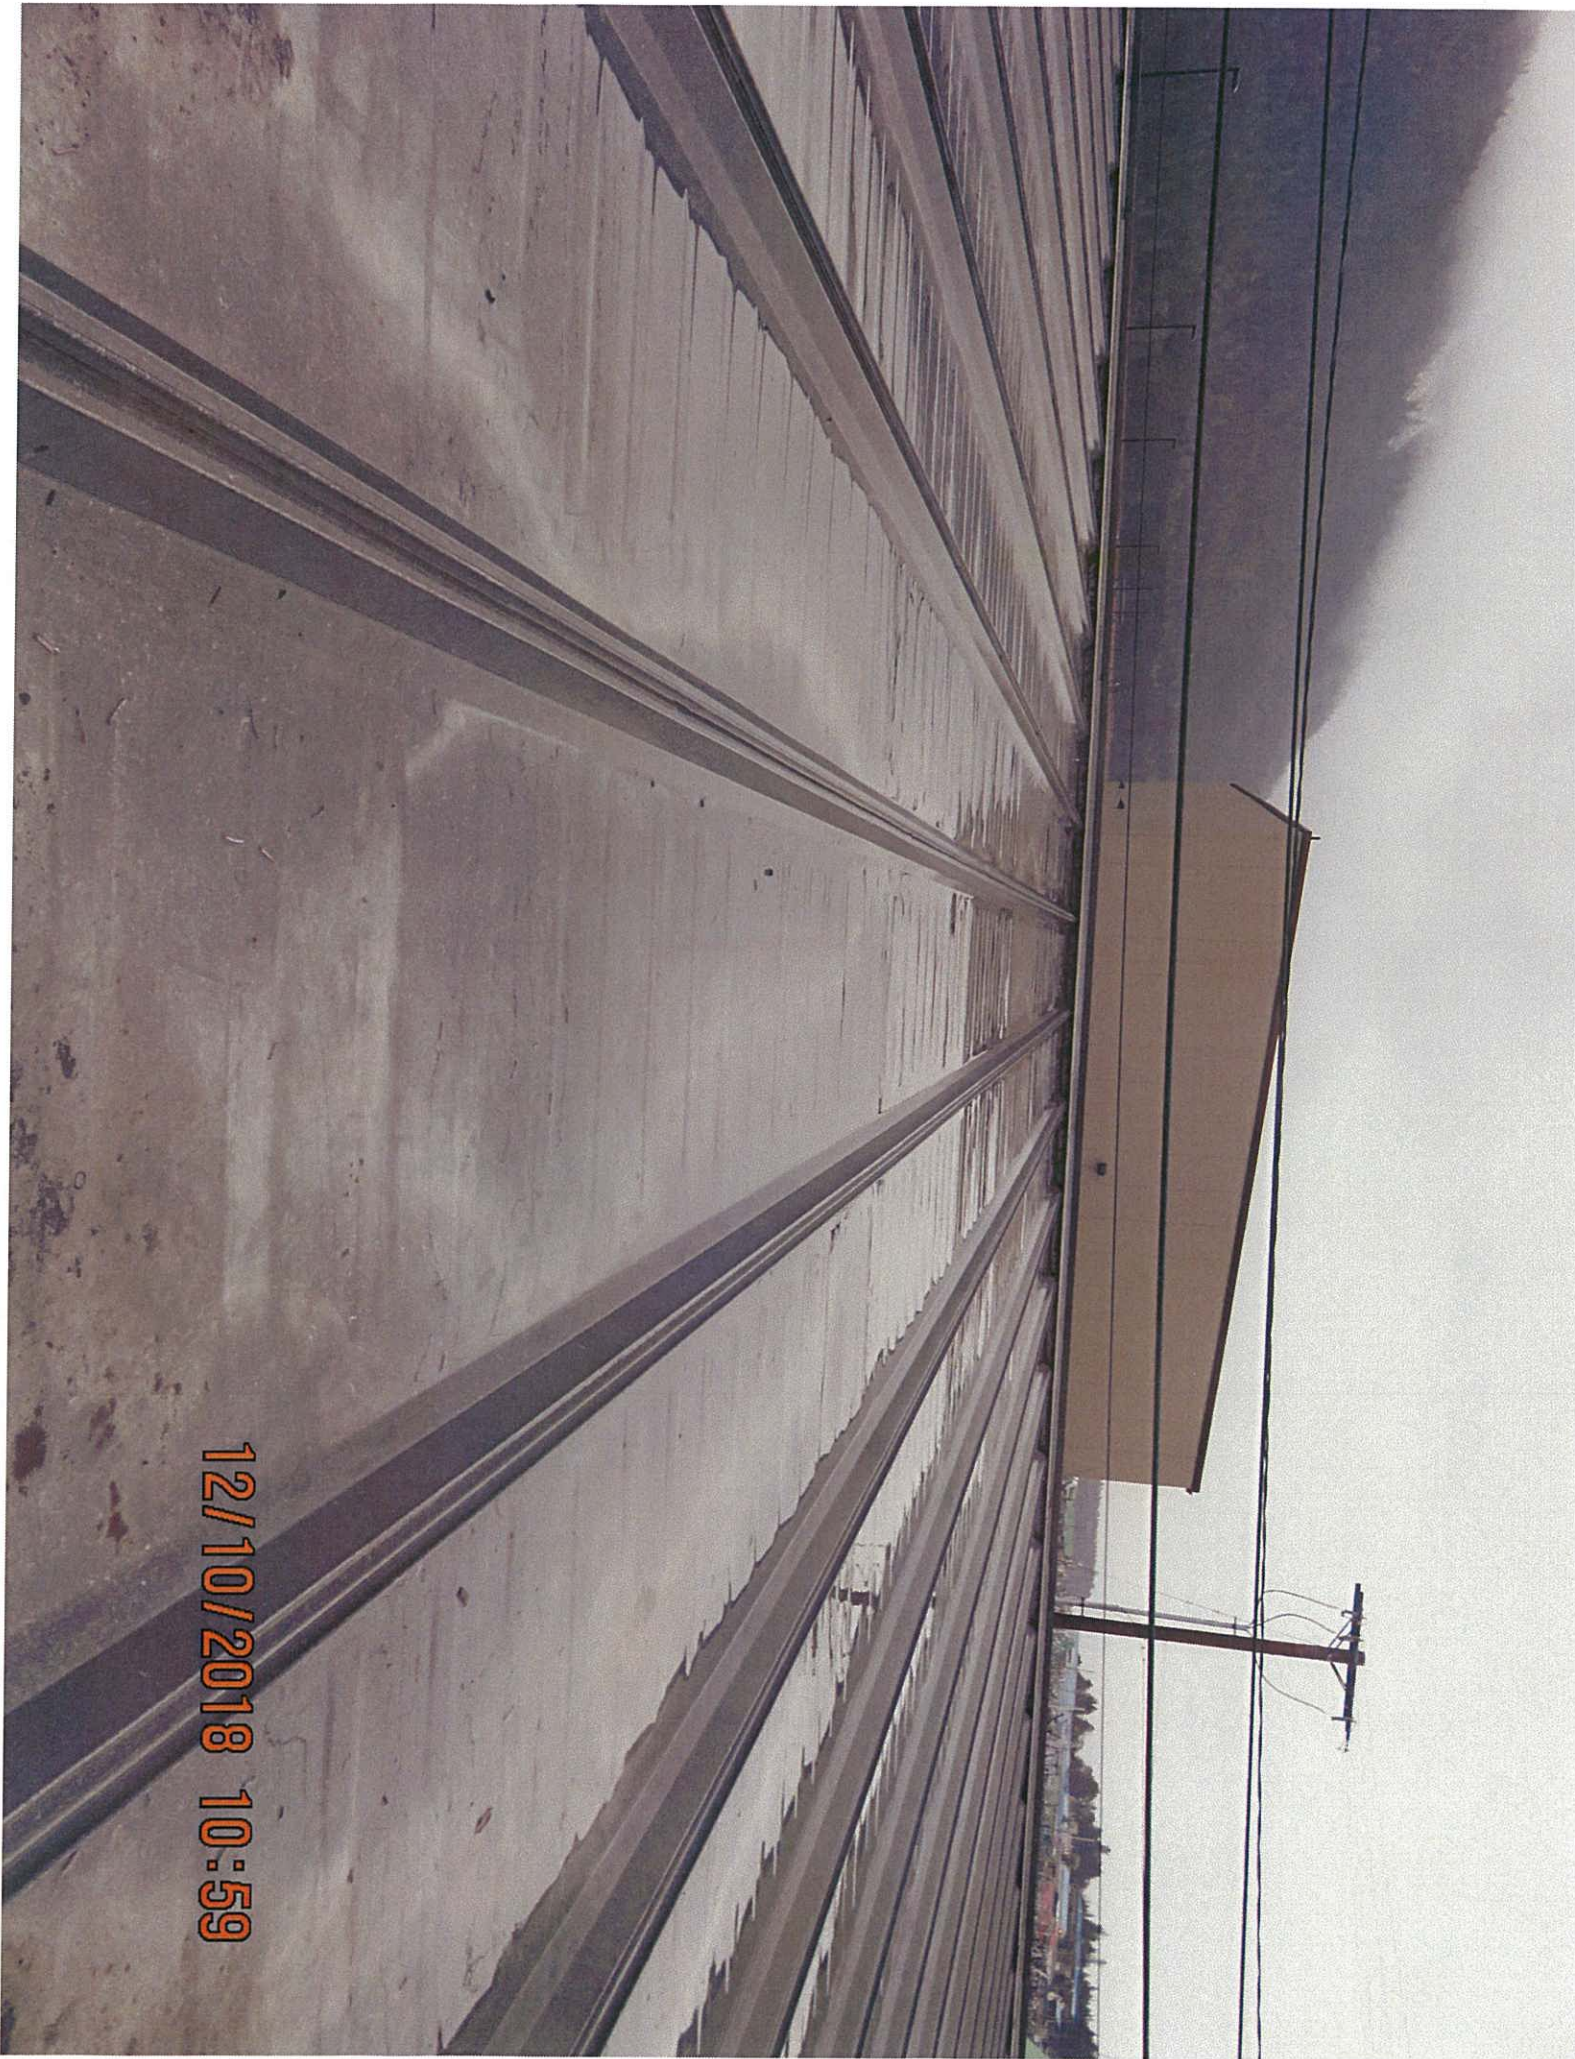
The roof panels appear to be in fair condition. There is some rusted areas on the gutter edge of the roof. The rust appears to be surface rust and is not flaking at this time. It would be beneficial to prolong the integrity of the roof to treat the rusted areas with OSFO and paint the rusted areas with primer and metal paint. There are several maintenance issues that need to be addressed. The screws on the top of the coping metal need to be replaced with washered roofing screws. The screw on the gutter edge of the metal panels should also be replaced with washered roofing screws. The seams and the rivets of the parapet flashing should be sealed with caulking or strips of ice and water shield. The flashing where the parapet flashing ties into the roof panels on the north and south section of the roof needs to be cleaned and re-caulked.
