KUPREANOF LANDING

1. INTRODUCTION

2. DETAILED ASSESSMENT

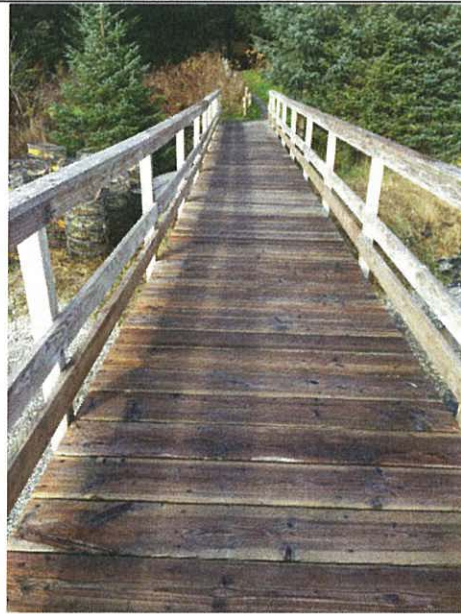
The timber approach (Photo 2) is in fair condition, with several issues requiring attention. The deck is in good shape, and is reportedly power washed annually. The handrails appear to be newer construction, but show a fair amount of movement / deflection when leaned on. It is unlikely these handrails could safely support more than 1 or 2 people per post spacing. Cracks were noticed in the handrail posts at most connections to the stringer (Photo 4).

2. Approach Top Side

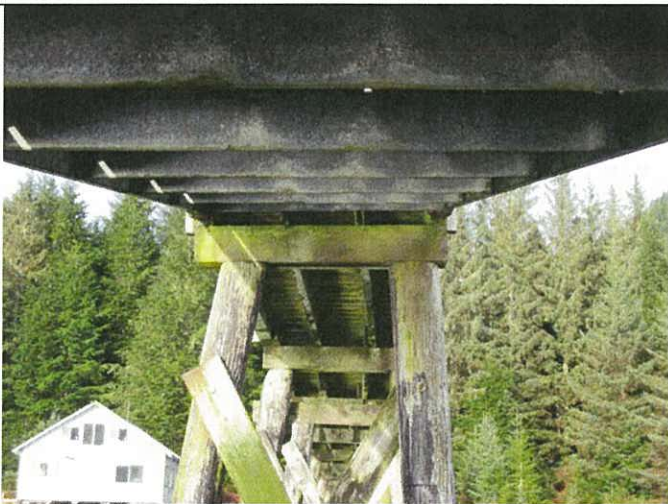
The stringers and pile caps appear to be in mostly good shape (Photo 3). Some of the pile caps have vertical cracks up to ¼" wide through their centers (Photo 6). The stringers are largely protected from the elements and appear to be in good condition. The 3rd pile bent from shore is leaning at approximately 10 degrees from vertical, towards the water.

3. Approach Framing

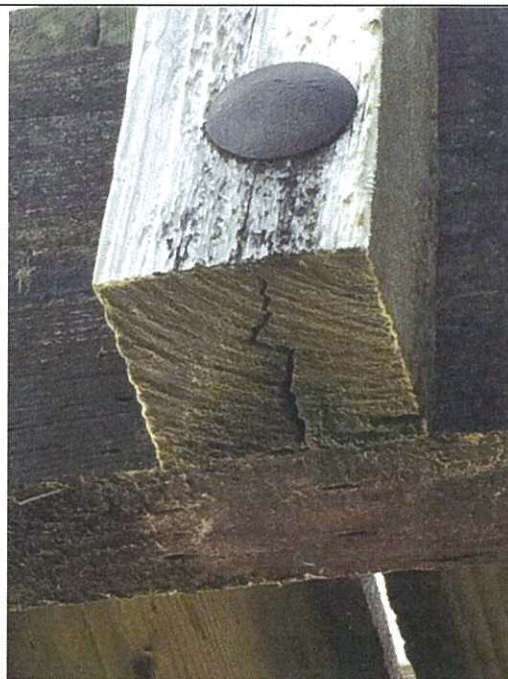
4. Typical Crack at Handrail Post

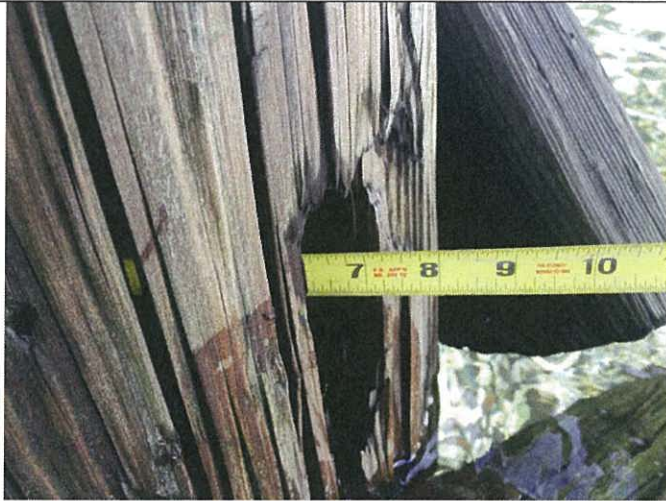
The timber bearing piles appear to be in good condition at first, however multiple piles were found to have hollow areas near the MLLW (0') water line (Photo 5). Only several of these locations were inspected in detail due to tide levels. In 2 cases, over 50% of the cross section was void. A 2011 Underwater inspection report, commissioned by the State of Alaska, found 12 of the approach piles to have large splits, hollow areas, or softness in the intertidal zone. The above referenced underwater inspection report was prepared for ADOT&PF Bridge Section, Project # 80803/BR-NBIS(65) & 80801/BR-NBIS(64)

**5. Hollow Approach Bearing Pile**

It is recommended that the soft and hollow piling be repaired or replaced. Given the age, condition, and location of the structure, a total in kind replacement may be a better long term solution than repairing only the damaged piling.

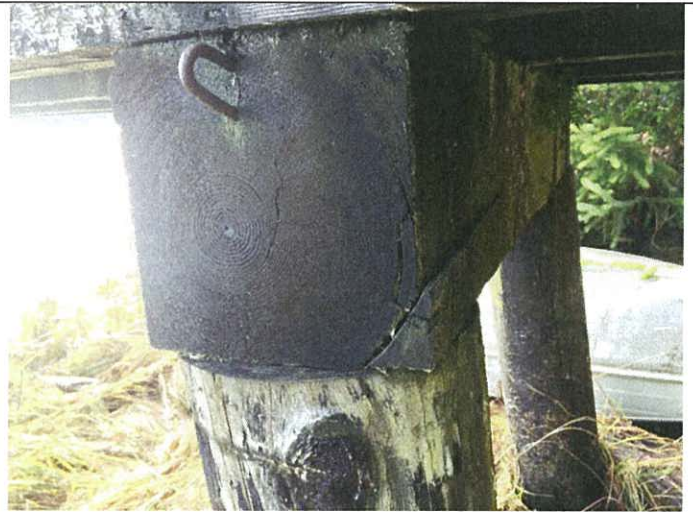
**6. Cracked Pile Cap**

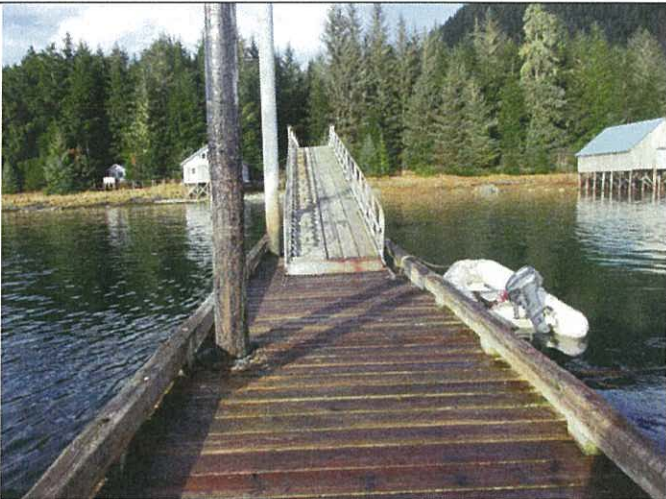
The steel gangway is in good condition (Photo 7), with only minor locations of coating loss and surface rust. The gangway is approximately 50' long, making it very steep at low tides, and not suitable for ADA access. It is recommended that the gangway be replaced with an 80' ADA accessible unit, as part of any significant rehabilitation to the approach structure or floating dock.

**7. Float and Gangway**

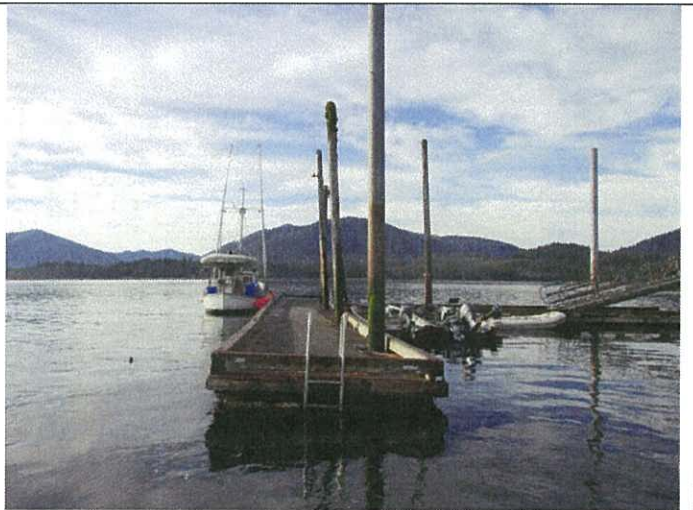
The timber float is in fair to poor condition, and it appears to be nearing its useful life. The float lists on the order of 5" to the West (Photo 8). The decking is mostly in fair condition with many boards being weathered, but all appear sound. There is light vegetation between the boards, which should be pressure washed or mechanically removed.

**8. Listing Float, note crooked pile**

It is recommended that the float be replaced with a heavy duty concrete, timber, or steel pontoon unit. The location is exposed, and heavy currents likely bring ice and other debris in contact with this float. The float does not appear to be on the verge of breaking loose, but it has reached its useful life. Without repair or replacement, it is not expected to be safely useable beyond the next 5 years. The float guide piling represent a serious issue if they continue to decay and corrode. These piling should be replaced.

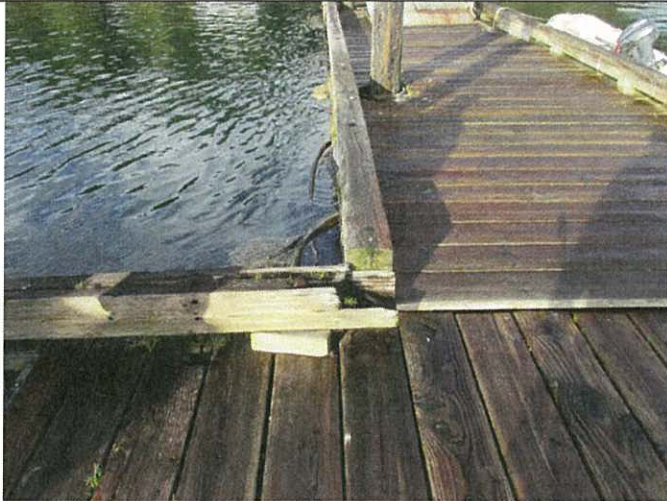
The bullrail shows heavy wear and weathering (Photo 12), but appears mostly structurally sound. One location of significant structural rot and damage was observed where the main float intersects the gangway landing float, to the south (Photo 9). This section of bullrail should be replaced.

9. Damaged bullrail and lip at float intersection

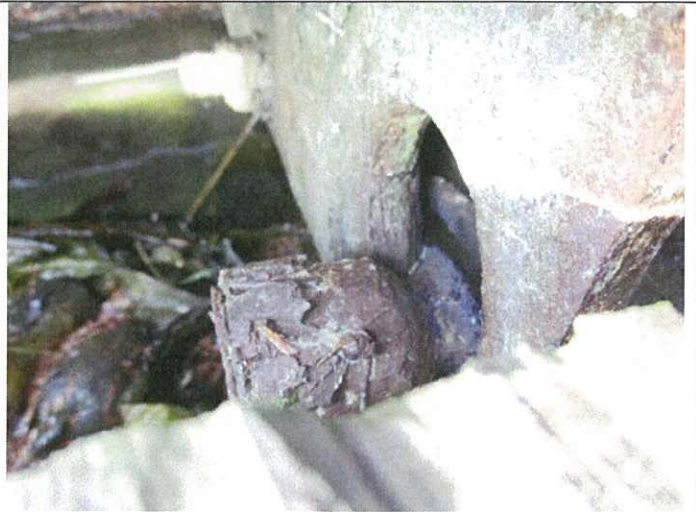
Corrosion in the form of surface rust is evident on many of the fasteners, though they appear to retain most of their sections. The hinge pins between the gangway float and the main float are heavily corroded and worn (Photo 10). They should be replaced. Failure of the hinge(s) will allow differential movement between the two float systems, but each float section is still secured in place with guide piling.

10. Worn and Corroded hinge components

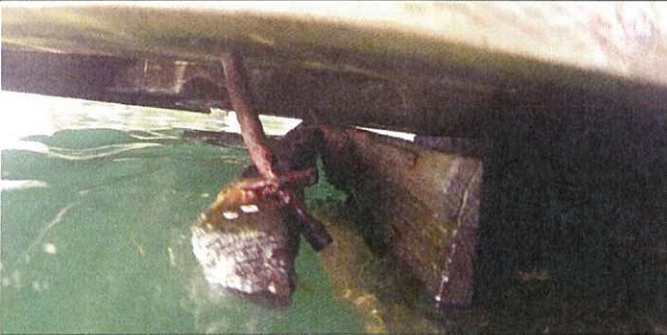
The flotation on the southeast corner of the float is heavily damaged. It appears outermost sill was split and the flotation is has been displaced (Photo 11). This type of damage can be anticipated at more locations, as some of the other sills appear rotted and split.

11. Broken Sill, Note missing flotation

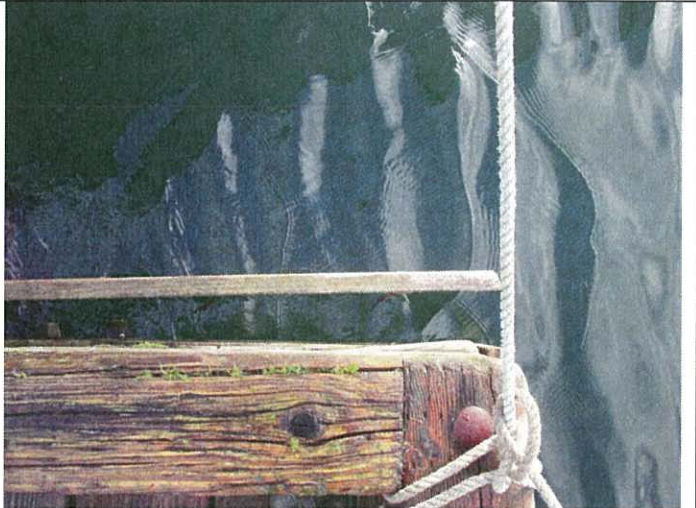
12. Worn Bullrail and Damaged Rub Board
